**By investigating some tragic accidents,
we may become better prepared for the future.**

**Most of the findings prove that accidents occur
because humans are involved in design of the ships,
and planning and performance of the voyages.**

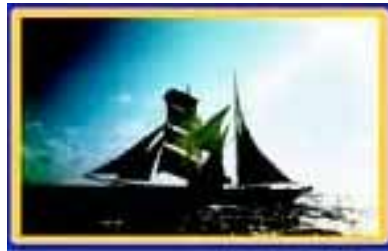
Albatross 1921-1961

- Sail training ship, later movie star, then sail training again
- Gaff schooner, converted to topsail schooner, and to brig/brigantine
- Originally regarded safe and well designed

1. With much sail aloft, in not extreme wind cond's, she suddenly heeled 45°
2. Water filled her in few minutes, 6 did not survive

Converted from schooner to a lofty brigantine:
Wind forces made her heel more and faster

Change of rig, placement of two boats
6ft above deck and new deckhouses
raised the gravity centre:
Reducing the Dynamic stability

Change of engine to a lighter model:
Reduced weight well below deck,
Thus raising centre of gravity even more

1949	1956
Centre of Gravity (above keel)	7,99	8,78
Heel angle to edge of deck	16,84	15,85
Downflood angle	58,4	57,2
Range of positive stability (degrees)	110	57,0

- 1: The sail area was not reduced**
- 2: The hatches were not closed, neither were watertight doors**
 (Investigations have concluded that the very calm weather before a sudden and extraordinary squall made this almost forgivable)
- 3, 4, 5, 6, 7..: Reduced stability after rebuildings and refits, inadequate stability tests**

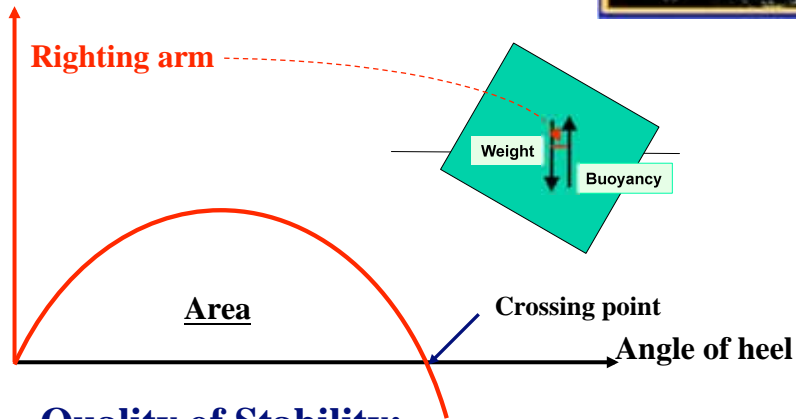
Stability-3: Dynamic Stability

Quality of Stability:

1. Large Area under the curve
2. Crossing point at a high angle

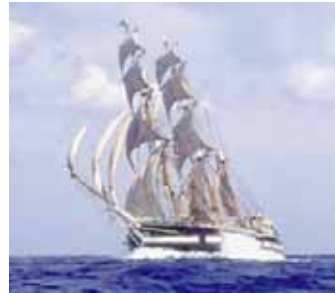
Marques

- General cargo schooner
- 1972-74 Rebuilt to brigantine, "went to the movies"
- 1976-77 converted to 3-masted barque
- 1981 Rig extended 8ft to take royals, studsails added
- 1960-84: Gradual transition to Sail Training

1. Strong wind and a freakish wave made her heel 90°
2. Water filled her in abt. one minute, 19 out of 28 lost their lives

**Converted from schooner to a lofty barque:
Wind forces made her heel more and faster**

Angle of downflooding: 60 degrees
Range of positive stability: 57 degrees

**Main hatch 9x13 ft was most often not covered,
in order to secure ventilation below deck**

**Gun ports acted as freeing ports.
All but two were sealed because of earlier damage.**

- 1: Gradually reduced stability from rebuildings and refits**
- 2: Conflict between the aim to secure future operation and security ?**
- 3: Freeing ports blocked, main hatch tarpaulins were not fully battened and wedged**

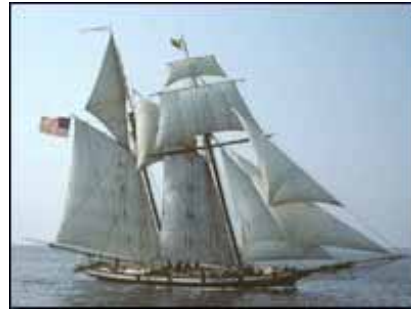
Pride of Baltimore

- 2-masted topsail schooner
- Replica of Baltimore clipper
- Huge sail area
- Sailed for City of Baltimore, and for private companies in US and S. America.
- 1986: Goodwill tour to Europe

1. Capsized and sank
2. 4 out of 12 died

- 1: Sailing in blue waters**
- 2: Conflict between the aim to secure a historic replica and security ?**
- 3: Water flooding into the ship, lack of watertight subdivisions**
- 4: 2 EPIRBs (Radio beacons) stored below deck**
- 5: Poor stability**

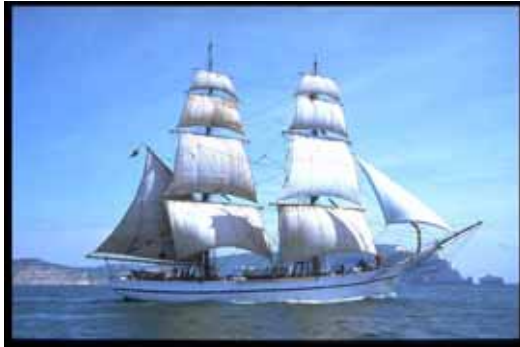
Maria Asumpta

Navigating too close to the Coast of Cornwall, England:

1. Started Main Engine, engine stopped
2. Hit the rocks, 3 out of 14 died

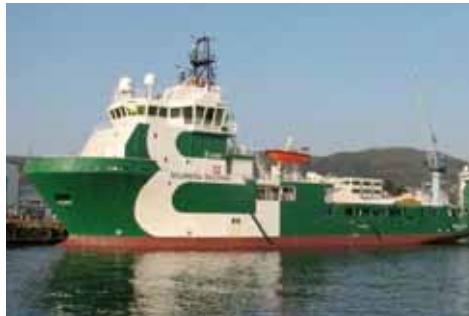
Bourbon Dolphin

Capsized during AH operations in the North Sea:

1. Was ordered for a heavy operation
2. Ship drifted, requested assistance
3. Towing pin released, reduced stability, capsized, 8 of 15 died

The yard delivered unrealistic anchorhandling calculations
The odd stability characteristics were not documented
Owners had no ISM routines for this particular ship
Crew lacked experience with the ship
Accept for an operation beyond the ship's normal capability
Inner towing pin retreated.
